**SIXTH FIVE-YEAR REVIEW REPORT FOR
SOUTH MUNICIPAL WATER SUPPLY WELL SUPERFUND SITE
HILLSBOROUGH COUNTY, NEW HAMPSHIRE**

**U.S. Environmental Protection Agency
Region 1
Boston, Massachusetts**

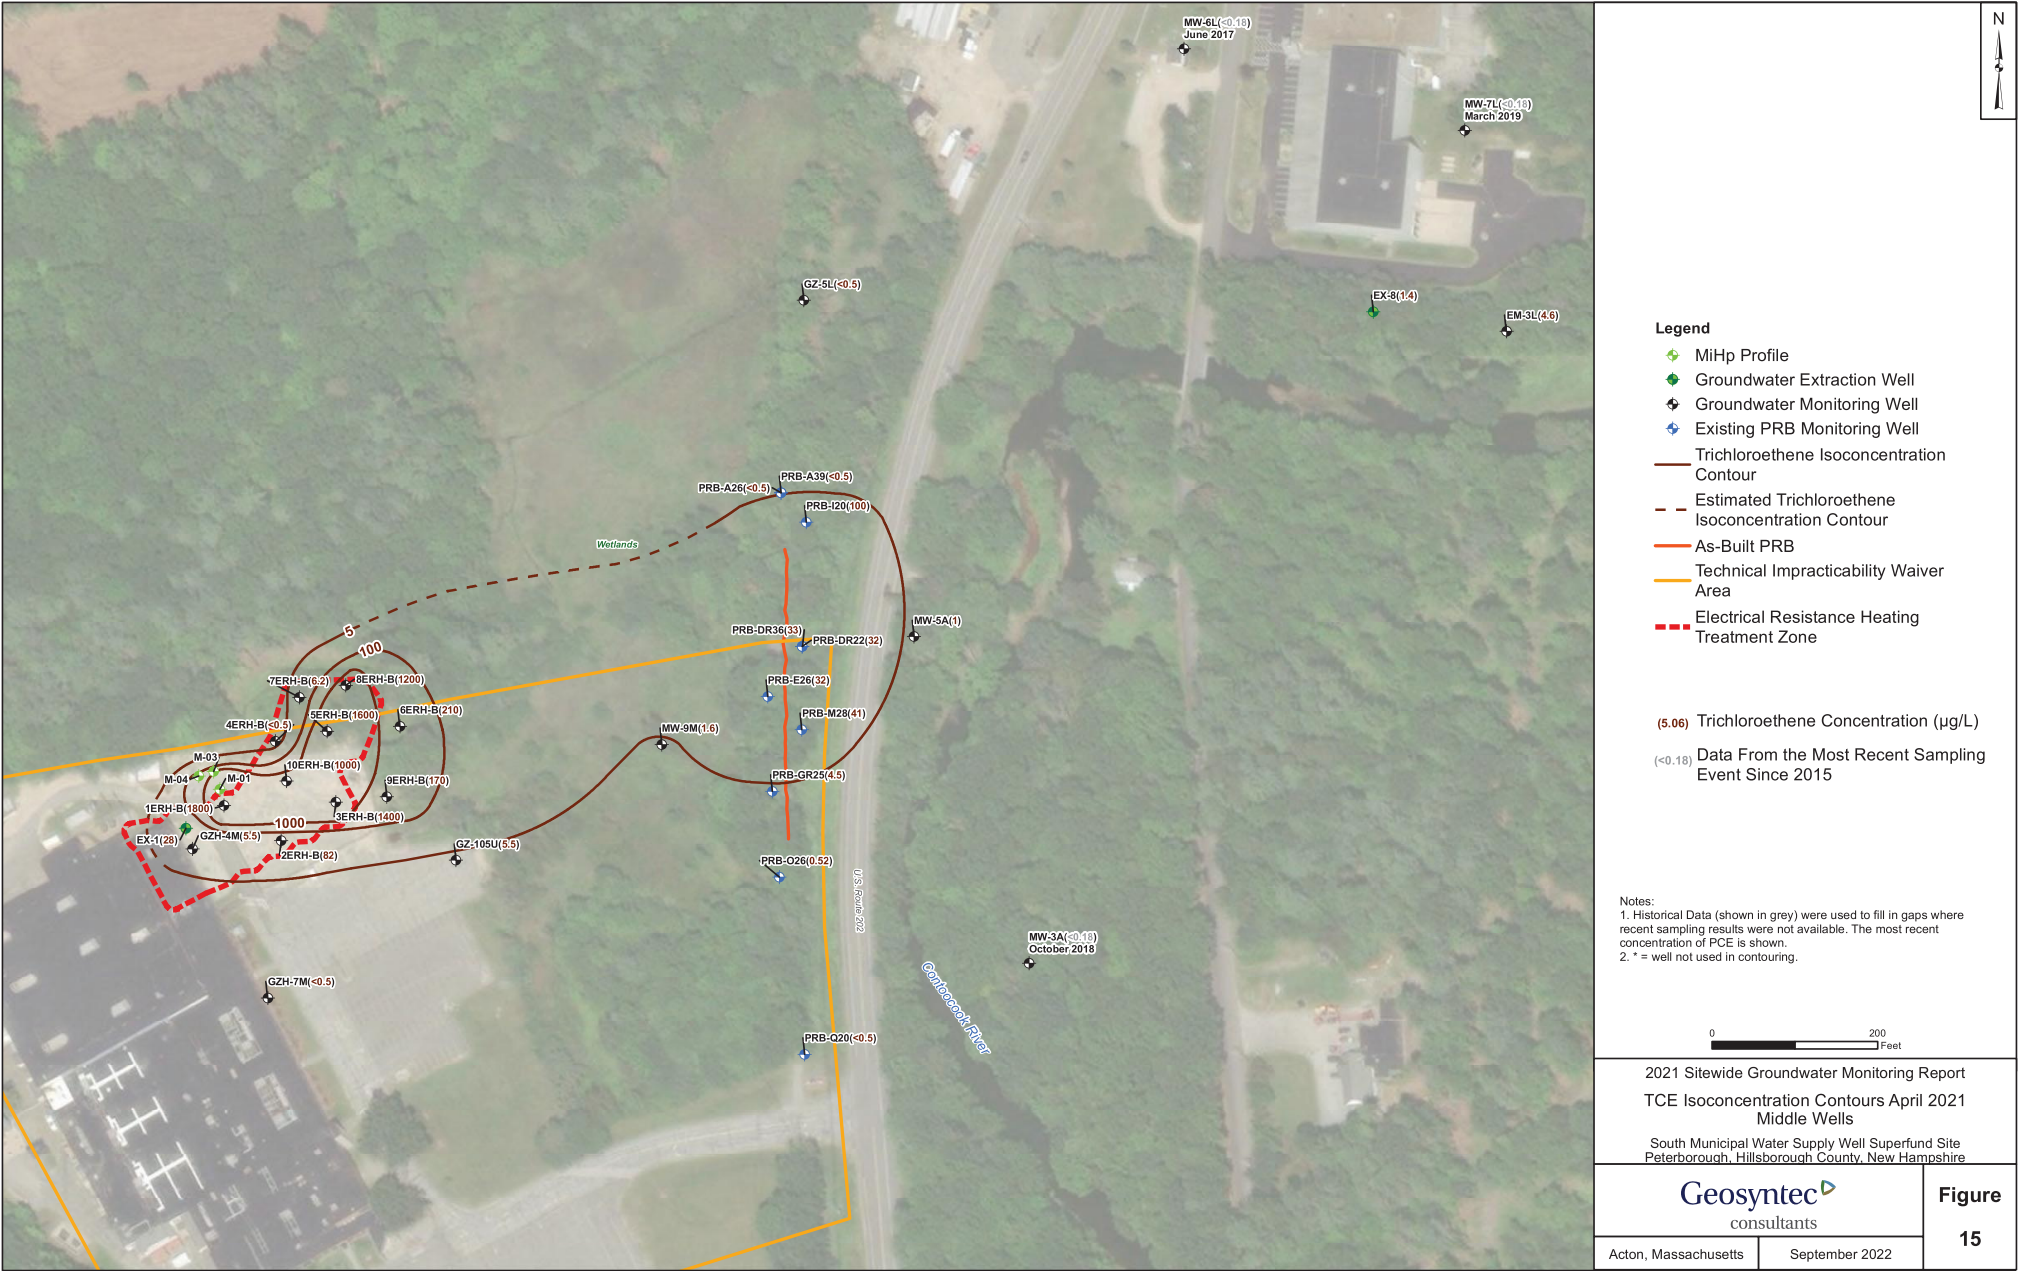
Figure F-9: TCE Isoconcentration Map in Middle Wells, March 2021

Source: Figure 15 from the Site’s January 2023 Post-Remedy Sitewide Long-Term Groundwater Monitoring Program Report (March 2021)

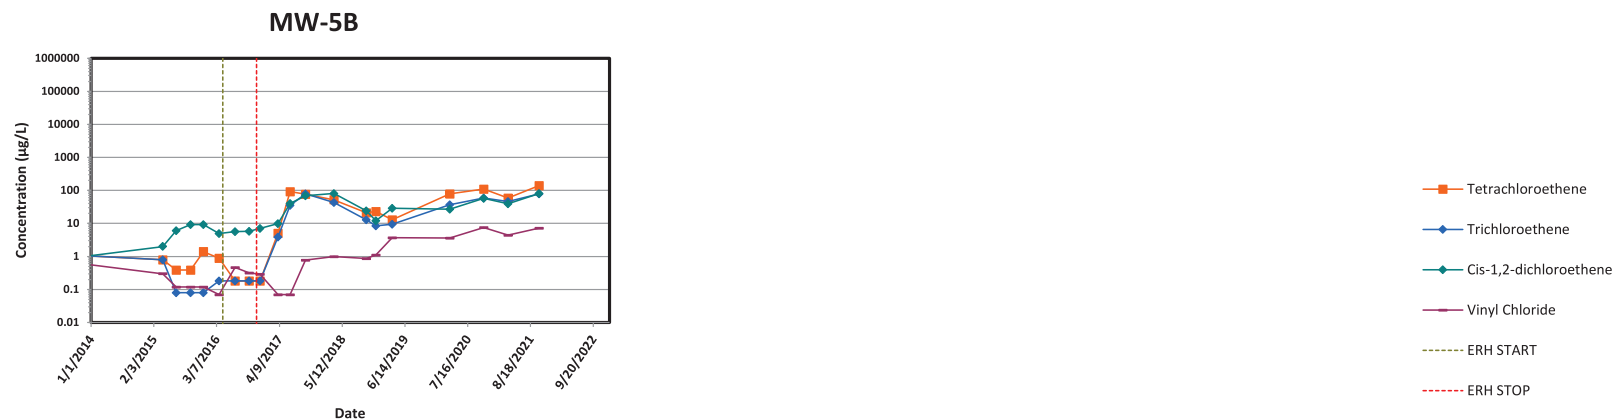
FIGURE 20C

PCE AND TCE TRENDS AT SELECT MONITORING WELLS
DILUTE PLUME AREA

Notes:
Non-detect concentrations are shown at the MDL

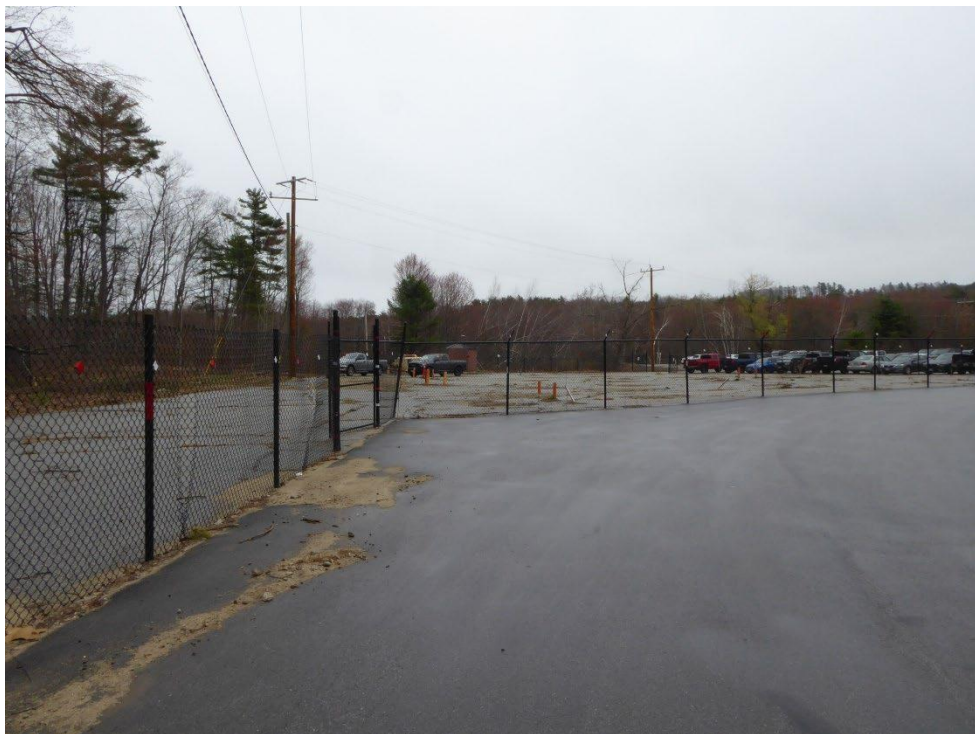
Location where ERH was conducted.

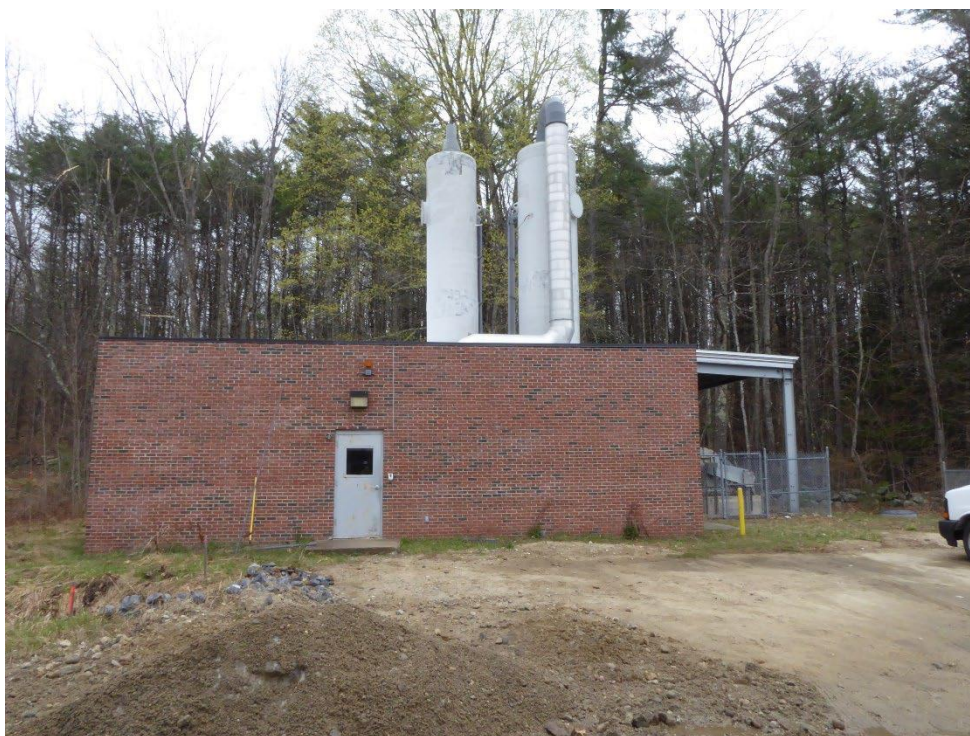
The former groundwater treatment plant building

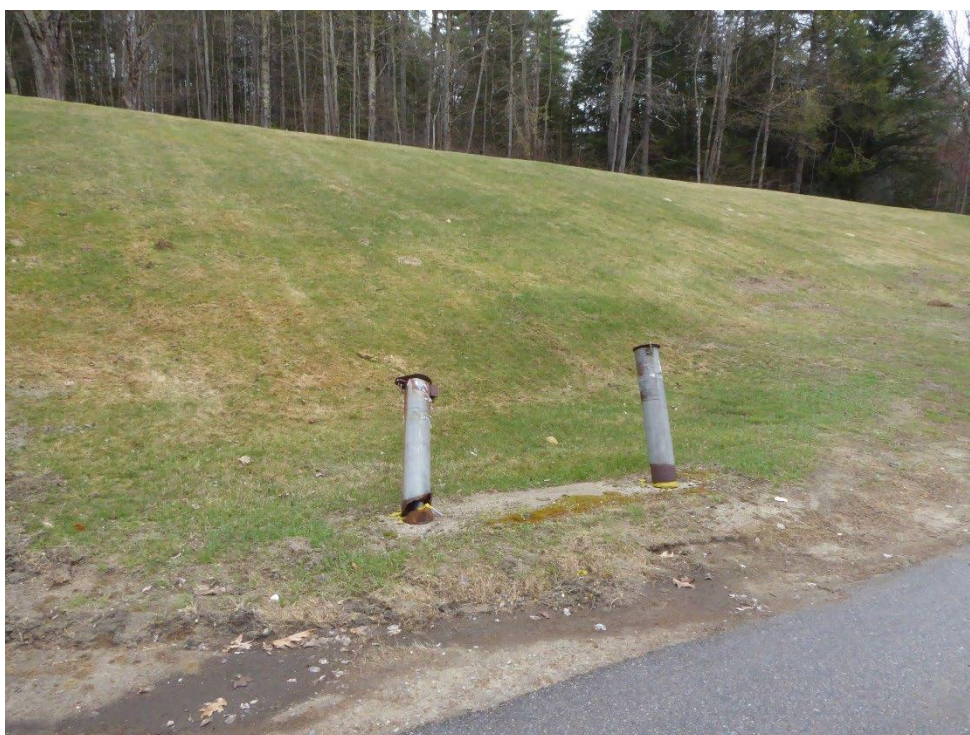
The Site is in generally good condition. Some groundwater monitoring wells had been damaged over the winter, likely by a snowplow when they were not visible under snow cover. The damaged monitoring wells were reportedly repaired following the inspection. No trespassing or vandalism was apparent. No protectiveness issues were observed. The PRP contractor was beginning activities for the installation of the PRB wall, including changing some stick-up groundwater monitoring wells to flush-mounted wells in the planned staging area. Site inspection participants discussed where the access road is planned, and other activities related to the PRB installation.

Groundwater monitoring wells damaged during plowing.

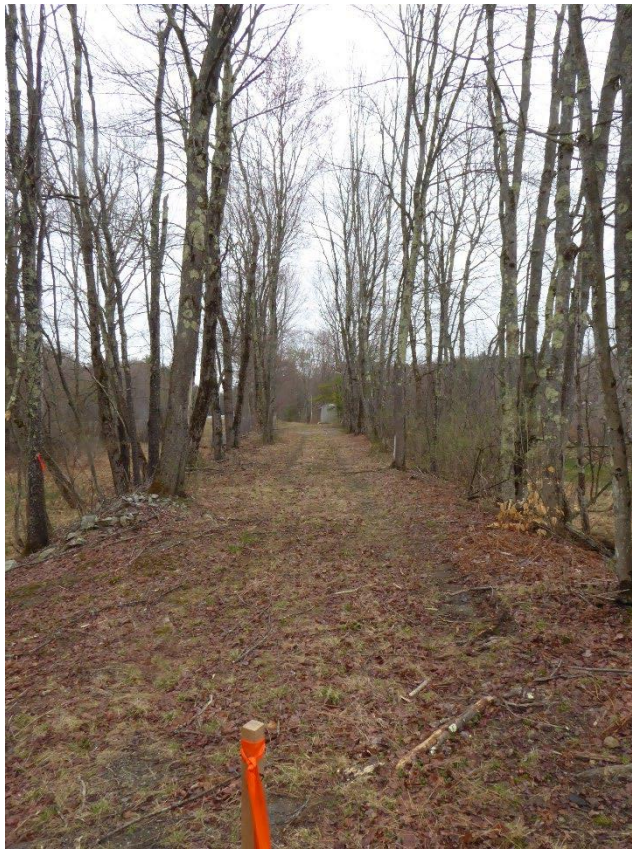
Location of the original PRB wall and the to-be-installed PRB wall

A 2018 report evaluating PRB performance found that it was not effectively treating the plume at any place along the length of the PRB, regardless of the influent concentrations and gradients. PRB monitoring results are discussed further in the Data Review section of this FYR Report. Construction of a replacement PRB is expected to begin in early 2024.

The 2018 FYR Report noted that, based on available groundwater data, the PRB wall was not effective in treating the plume. Groundwater monitoring results indicate that VOC concentrations downgradient from the PRB continue to exceed cleanup levels, indicating that the PRB continues to not meet its treatment objectives. Construction of a new PRB is expected to begin in 2024.

OU(s): 1	Issue Category: Remedy Performance			
	Issue: The existing PRB is not effectively treating the plume at any point along the wall regardless of the influent concentrations and gradients. A replacement PRB is necessary.			
	Recommendation: Complete the replacement PRB in 2024, as planned.			
Affect Current Protectiveness	Affect Future Protectiveness	Party Responsible	Oversight Party	Milestone Date
No	Yes	PRP	EPA/State	12/31/2024

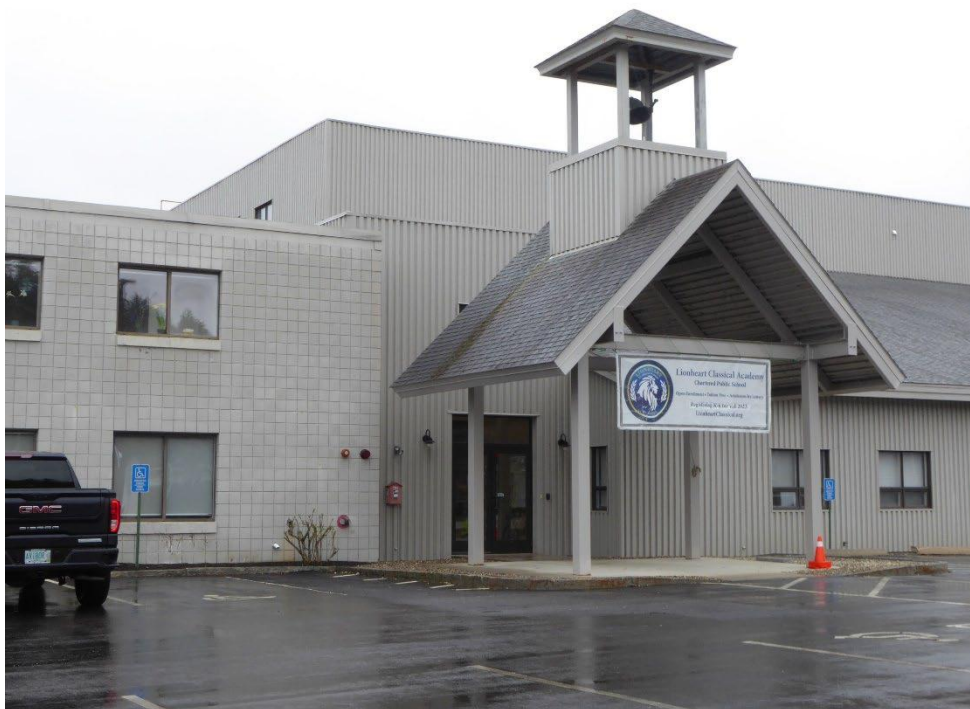
School potentially located over the downgradient groundwater plume.

In addition to soil gas, semi-annual groundwater monitoring data is compared to EPA VISLs to evaluate the potential for vapor intrusion at the Lionheart Classical Academy. Annual soil gas sampling is planned until an effective replacement PRB is in place and groundwater concentrations near the Lionheart Classical Academy show a decreasing trend.

Recommendation: Continue to monitor the potential for vapor intrusion at the school.				
Affect Current Protectiveness	Affect Future Protectiveness	Party Responsible	Oversight Party	Milestone Date
No	Yes	PRP	EPA/State	9/29/2026

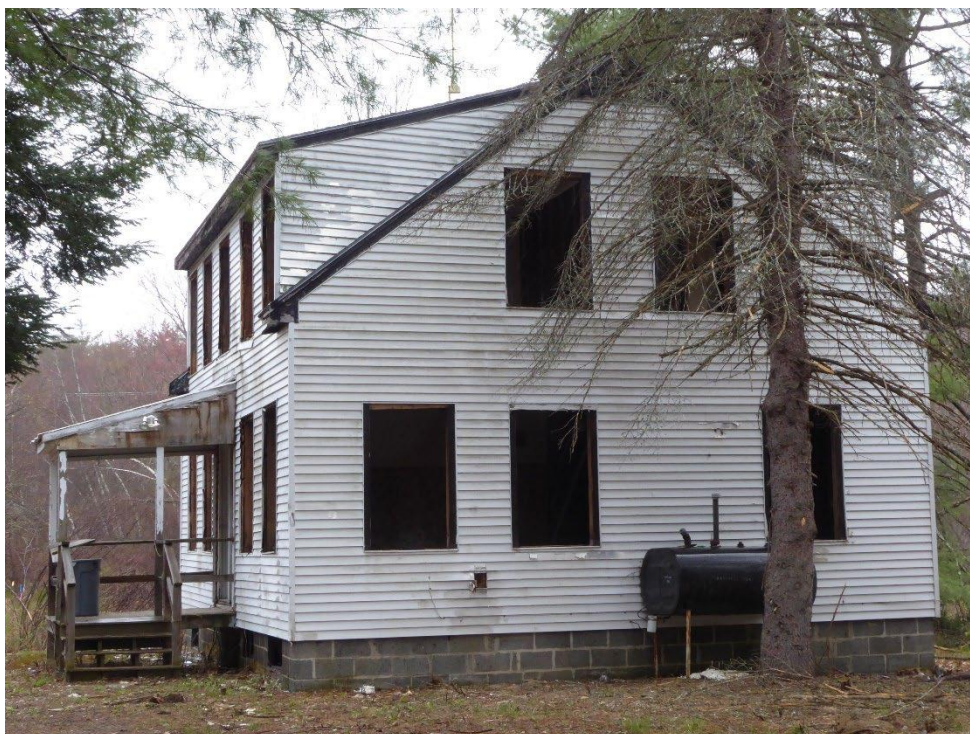
Uninhabited residence potentially located over the downgradient groundwater plume.
